Finite Element Analysis of Slope Face Storm Shelter

Technical Report Submitted to
OZ Saferooms, Del City, OK.

Rochester Institute of Technology

October 2017

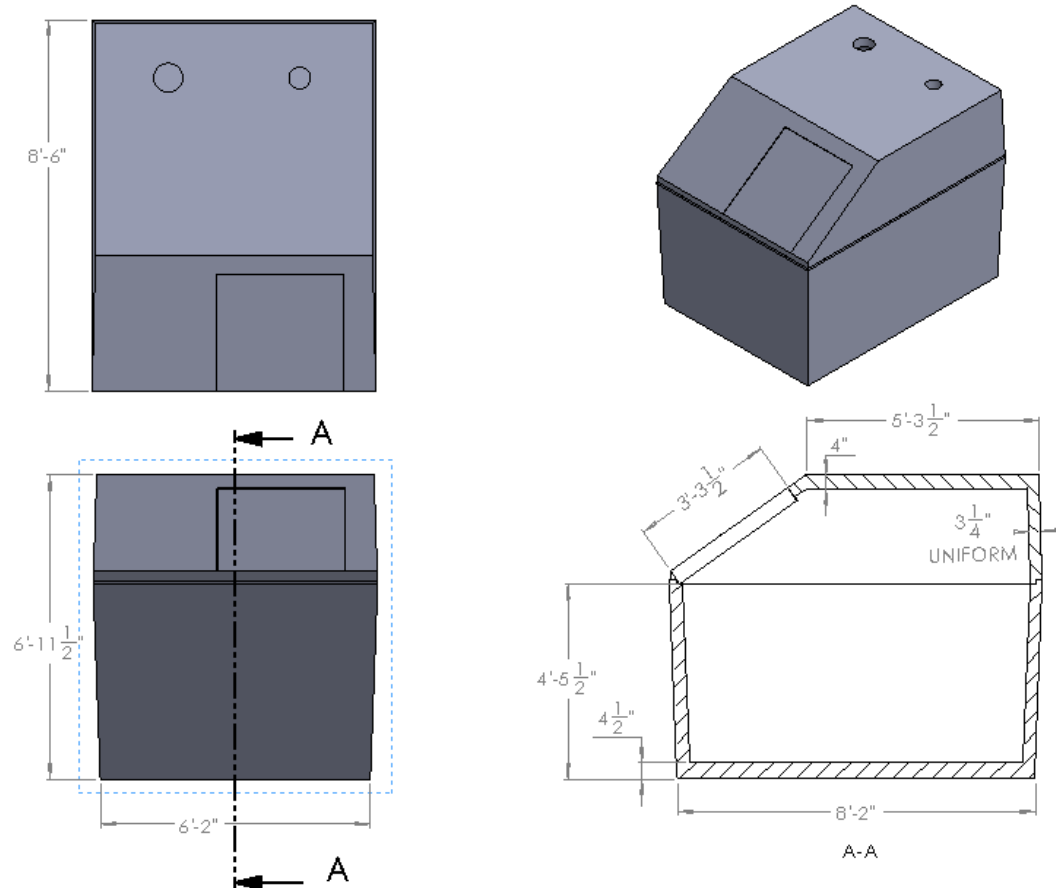
Figure 2.1: SolidWorks model for the slope face tornado shelter. Rebar is not included in this model. The base of the design is submerged below ground during implementation. The soil is not included in this image for clarity. General dimensions are provided for an understanding of the design scale.

A SolidWorks 3D model was constructed for the 6' x 8' Slope face shelter according to specifications provided by OZ Saferooms Technologies. Dimensional drawings are shown in **Figure 2.1** below. For the purpose of displaying the shelter's general size and shape, some dimensions were omitted. Notice that there is a taper angle to the base's vertical walls of 2.14° and another taper angle to the top's vertical faces of 1.9° . The ventilation holes on the shelter roof have diameters of 8" and 6" respectively [1]. Soil was modeled to add soft compression to the contact between the ground and shelter, increasing the accuracy of the dynamic simulation.

The model is comprised of three separate components. The top of the shelter is glued and bolted to the recessed bottom structure at a seal joint [1]. The door was modeled as a steel plate and rests in the opening at the top of the shelter. For additional details, an exploded view of the assembly can be seen in Appendix 1.

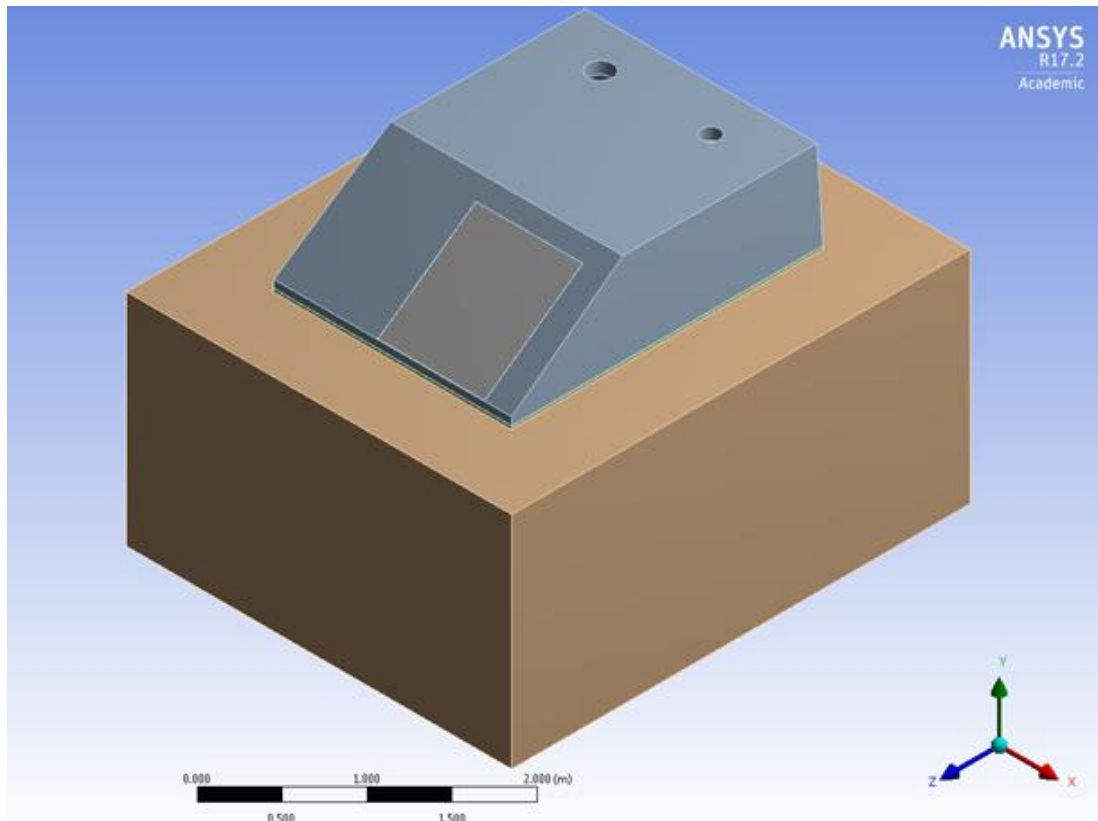
Figure 3.1.1: ANSYS model for the slope face shelter. Meshing not shown in this visual.

Once the SolidWorks model was created, it was imported in ANSYS 17.2 and meshed to create the elements and nodes that would be analyzed in LS-DYNA. **Figures 3.1.1** and **3.1.2** show the ANSYS model without and with meshing.

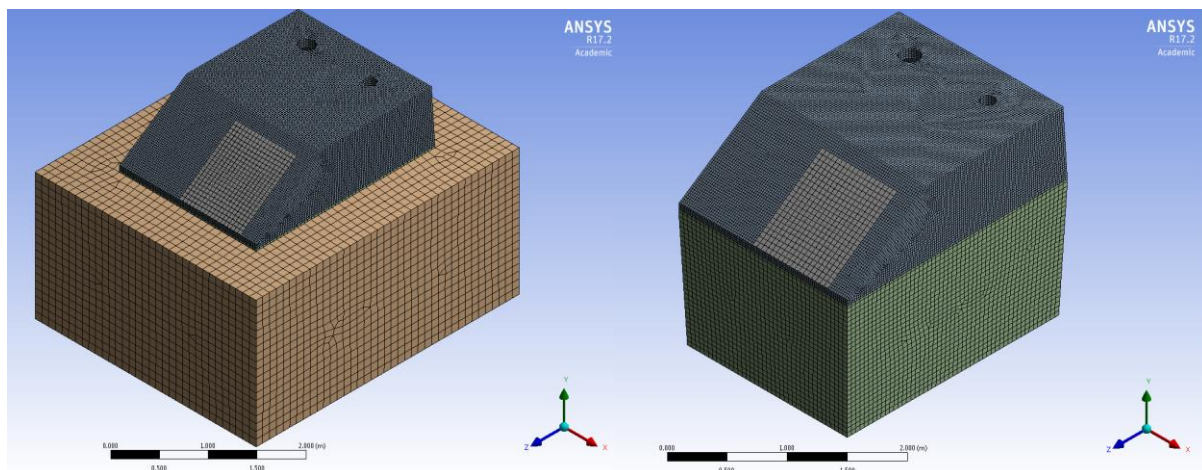
Figure 3.1.2: ANSYS model for the meshed slope face shelter. The model is shown with soil (left) and without (right).

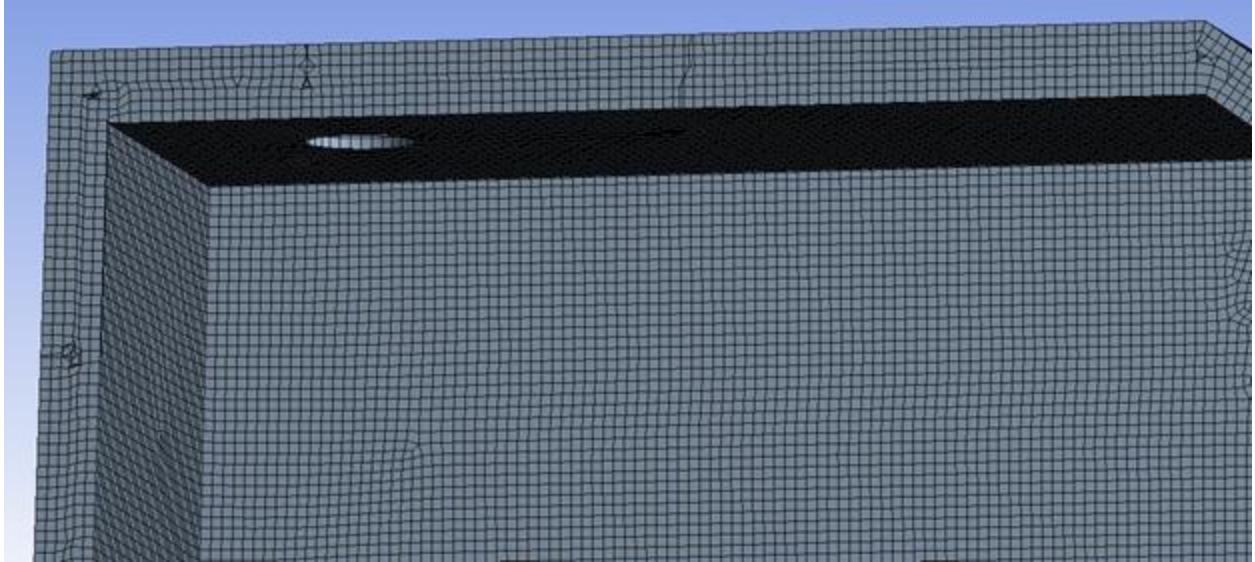
Figure 3.3.1: Cross-sectional view of the meshed lattice, positioned at the inside corner of the roof of the Slope face shelter . Note that it is predominantly hexahedral with few lattice imperfections.

In ANSYS, a mesh that provided clean hexahedral elements and minimal lattice imperfections on the top surface was required. **Figure 3.3.1** and **Figure 3.3.2**, shown on the following page, display the cross-sectional lattice and top surface lattice of the shelter, respectively. **Table 3.2** presents the parameters used to mesh the respective shelter components along with the corresponding element quantities. Notice that the soil, door, and base were assigned meshes of larger lattices since they were less critical to the impact analysis. This translates to more accurate results in the impact zone while reducing computational time.

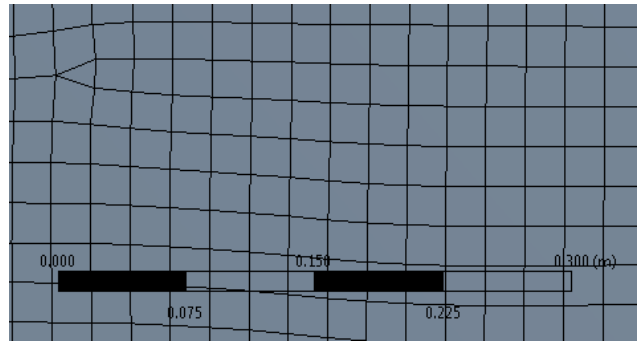
Figure 3.3.2: View of the meshed lattice on the top surface of the Slope face shelter. Note that the mesh is predominantly hexahedral with few lattice imperfections.

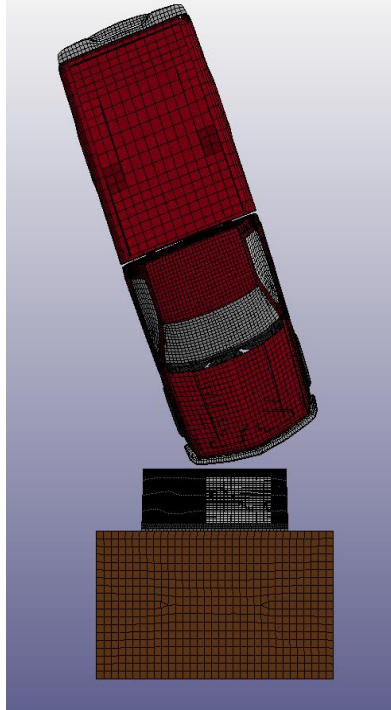
Figure 4.2: Chevrolet C2500 detailed design model provided by the NCAC/CCSA [3]. The truck was given a 20° tilt angle from the vertical axis.

A Chevrolet C2500 model, developed by the NCAC/CCSA [3], was then imported and aligned in the model for crash impact analysis. **Figure 4.2** illustrates the detailed vehicle model tested in this report. The detailed model contains internal design structures such as the vehicle's seats, as well as an accurate weight balance for impact testing.

The vehicle was positioned 2.16" above the top surface of the Hausner shelter in ANSYS. The truck's center of mass was located overtop the shelter roof and the vehicle was assigned a 20° tilt from the vertical axis to emulate a realistic impact scenario.

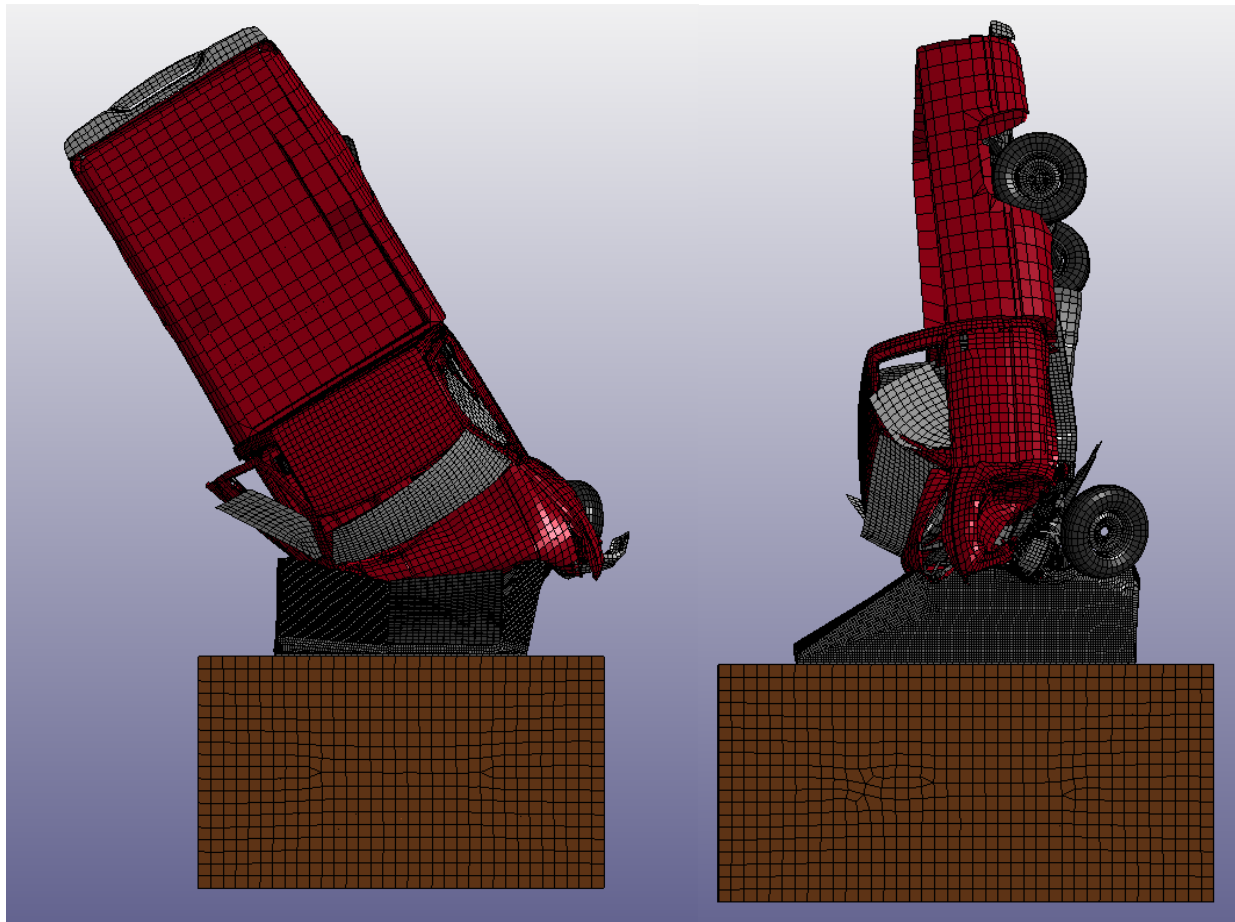
Figure 5.1: Post-simulation collision of the pickup truck into the slope face shelter.

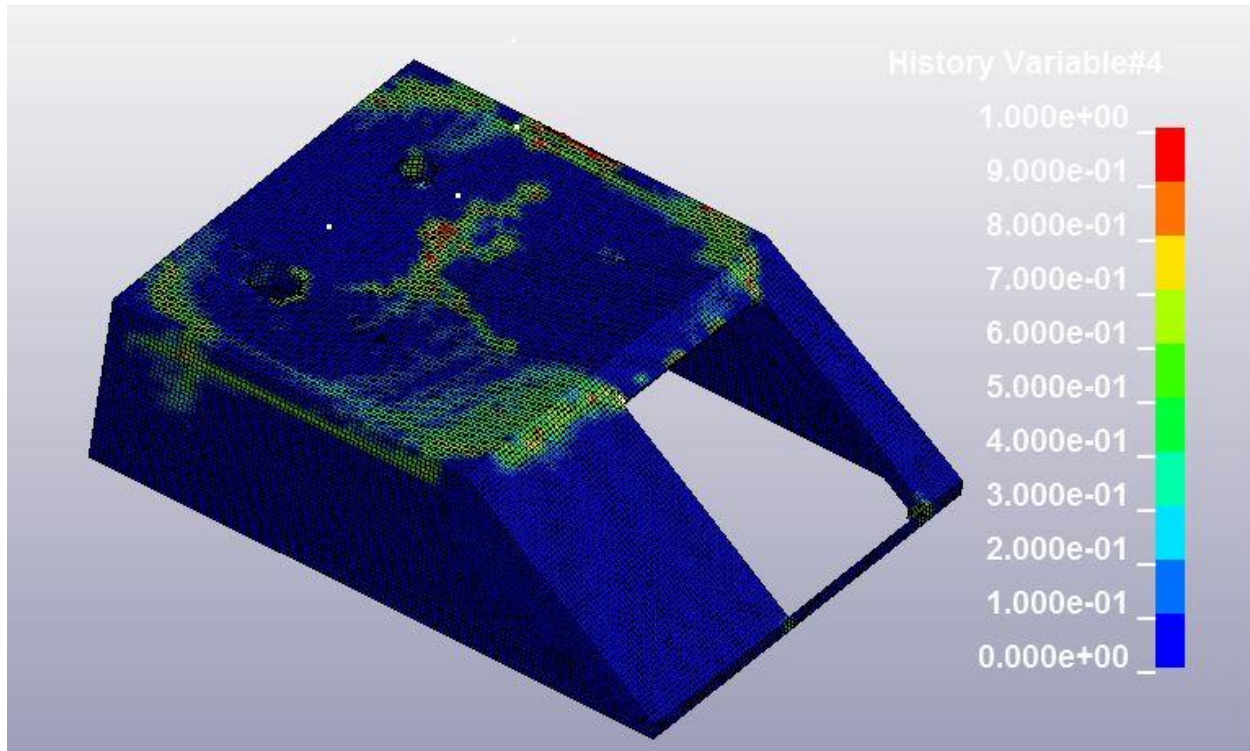
Figure 5.1.1: 12-Inch slope face shelter (12" Run 6) impact at 0.049s. The first cracks are appearing in the center of the roof.

This simulation was performed with the same parameters used in the OZ Saferoom analysis [6]. Results show that the roof of the 12" rebar model failed from the center, with cracks propagating outward toward the corners of the structure, typical of reinforced concrete failure. Damage was also seen at the perimeter of the concrete structure as the weight began to accumulate on the rooftop and put pressure on the surface. The roof displayed visible deflection, indicating the beginning of a collapse in the design. Holes formed by the end of the simulation, demonstrating

that the shelter was unable to withstand the impact. It was also observed that the door warped and lost contact at its supports. The following figures show key instants in time where cracks and holes began forming on the shelter top. For clarity, only the top part of the shelter is shown. A separate figure displays the damage to the door post-simulation. The full animation of the simulation is captured on the attached CD, under filenames **RUN6_Front.wmv** and **RUN6_top_HV4.wmv**.

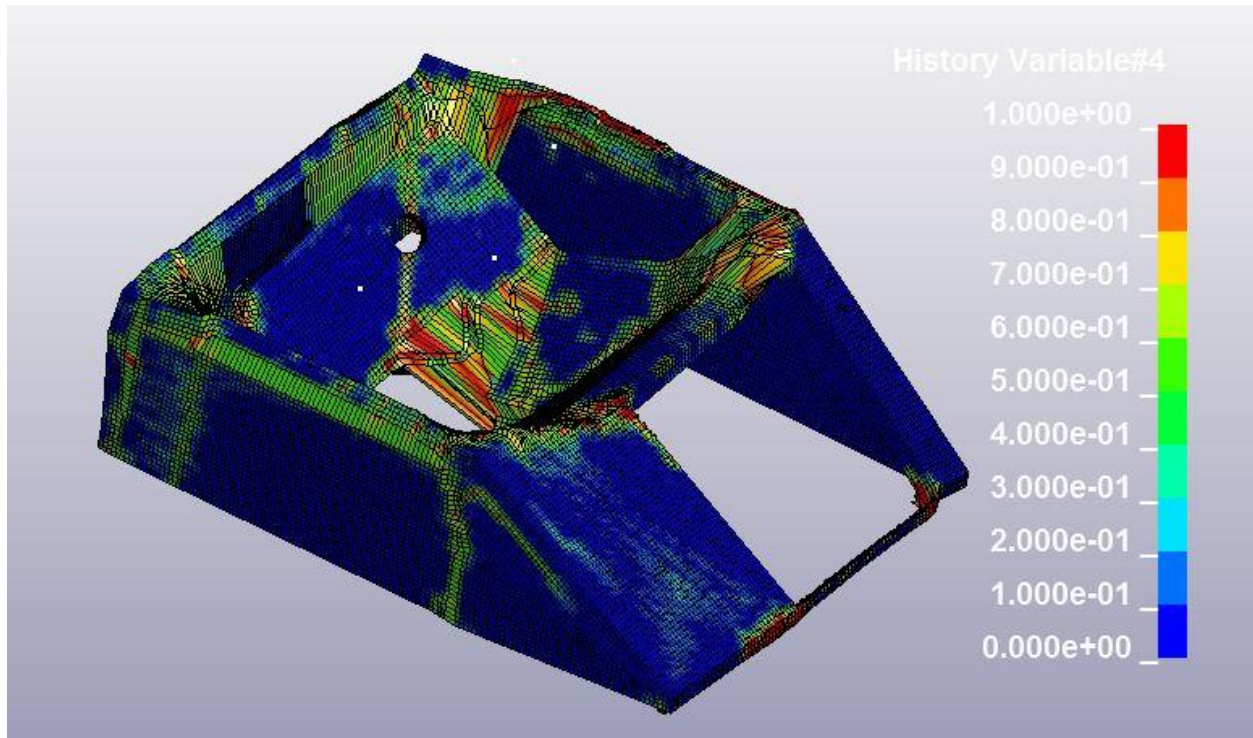
Figure 5.1.2: 12-Inch slope face shelter (12" Run 6) impact at 0.150s. Holes have formed in the shelter roof. The simulation has reached normal termination.

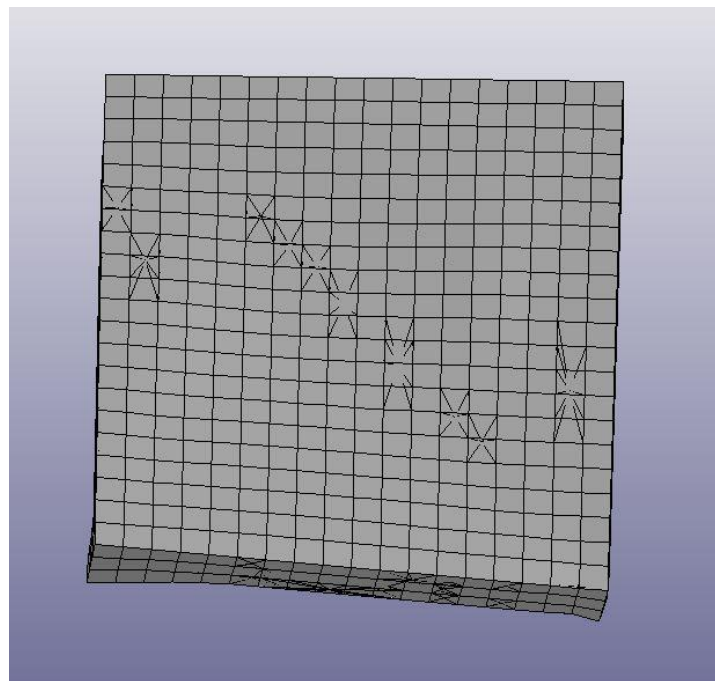
Figure 5.1.3: 12-Inch slope face shelter (12" Run 6) door at the end of the simulation, showing warpage.

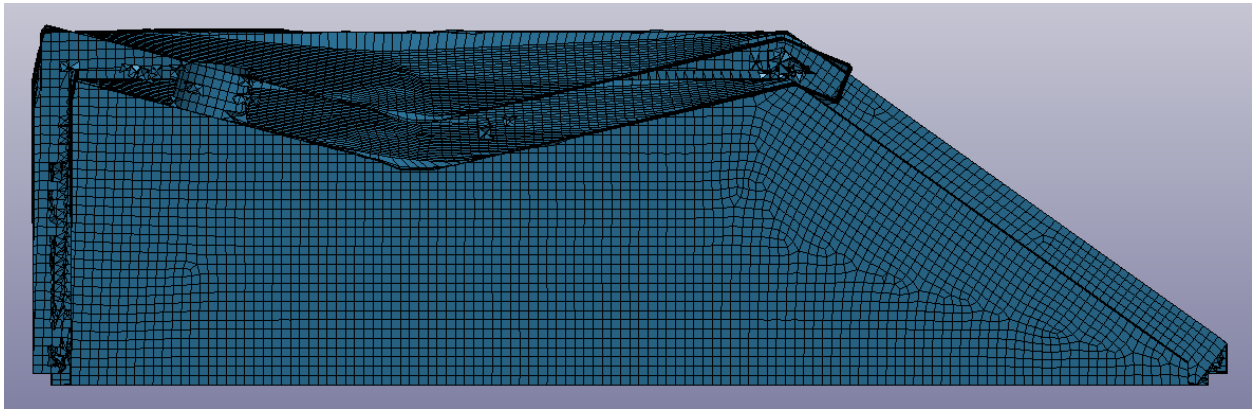
Figure 5.1.4: 12-Inch slope face shelter Rebar Model (12" Run 6) cross section, displaying maximum deflection in the concrete before holes formed in the structure. The capture was taken 0.063s into the simulation.

Figure 5.1.4 shows the cross-sectional view of the maximum displacement immediately before holes formed in the structure. This image shows large plastic deformation on the roof of the structure during impact and shearing of the elements on the edges. **Figure 5.1.5** shows the rigid body displacement for the top during the time of simulation. Averaging the entire rigid body vertical displacement of the roof, the top of the shelter sinks 146 mm. However, selecting nodes at the center of the shelter roof, the displacement was seen to be 175 mm immediately before holes began forming. The maximum vertical acceleration was 75 m/s^2 , shown in **Figure 5.1.6**.

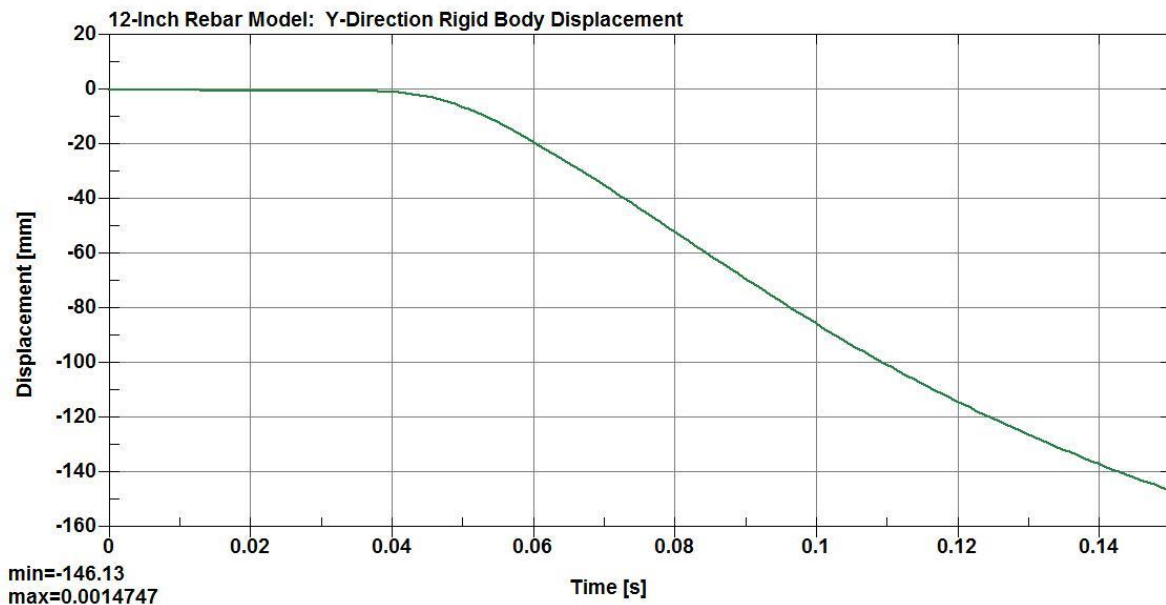
Figure 5.1.5: 12-Inch Rebar Model (12" Run 6): Rigid Body Vertical Displacement of the slope face shelter top with no filter applied.

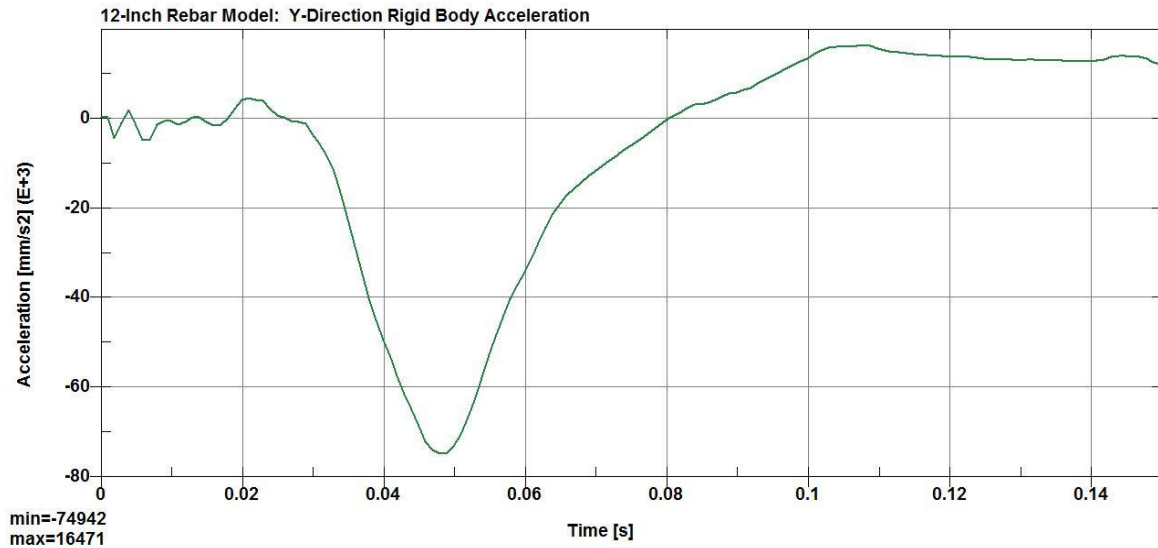
Figure 5.1.6: 12-Inch Rebar Model (12" Run 6): Rigid body acceleration of the slope face shelter top in the vertical direction. A 9-point averaging filter was applied to better isolate the acceleration signal from the noise.

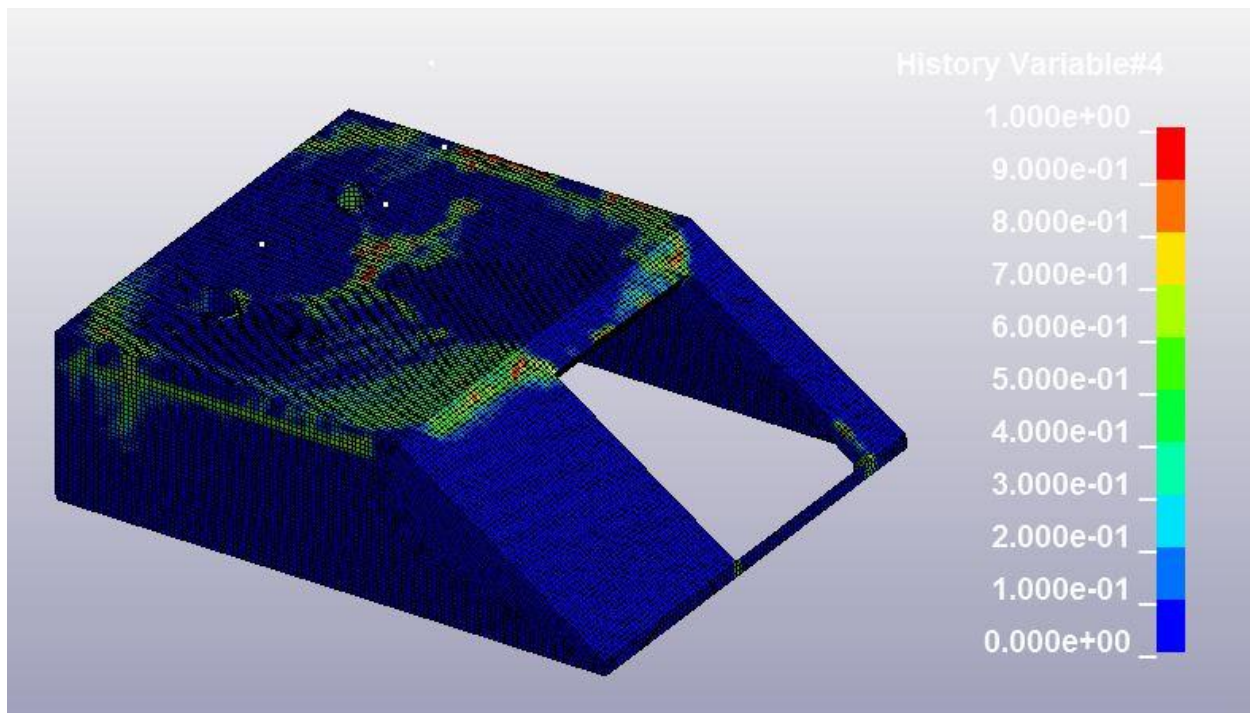
Figure 5.2.1: 14-Inch slope face shelter (14" Run 3) impact at 0.049s. The first cracks are appearing in the center of the roof.

A separate simulation was run using a rebar structure spaced 14" with the same parameters used in the 12" rebar model analysis. Results show that the roof of the 14" rebar model failed in the same way that the 12" model failed, with cracks forming along the perimeter and in the roof center. The following figures show key instants during the simulation where cracks and holes began forming on the shelter top. For clarity, only the top part of the shelter is shown. A separate figure displays the damage to the door post-simulation. The full animation of the simulation is captured on the attached CD, under filenames **RUN3_Front_HV4.wmv** and **RUN3_Top_HV4.wmv**.

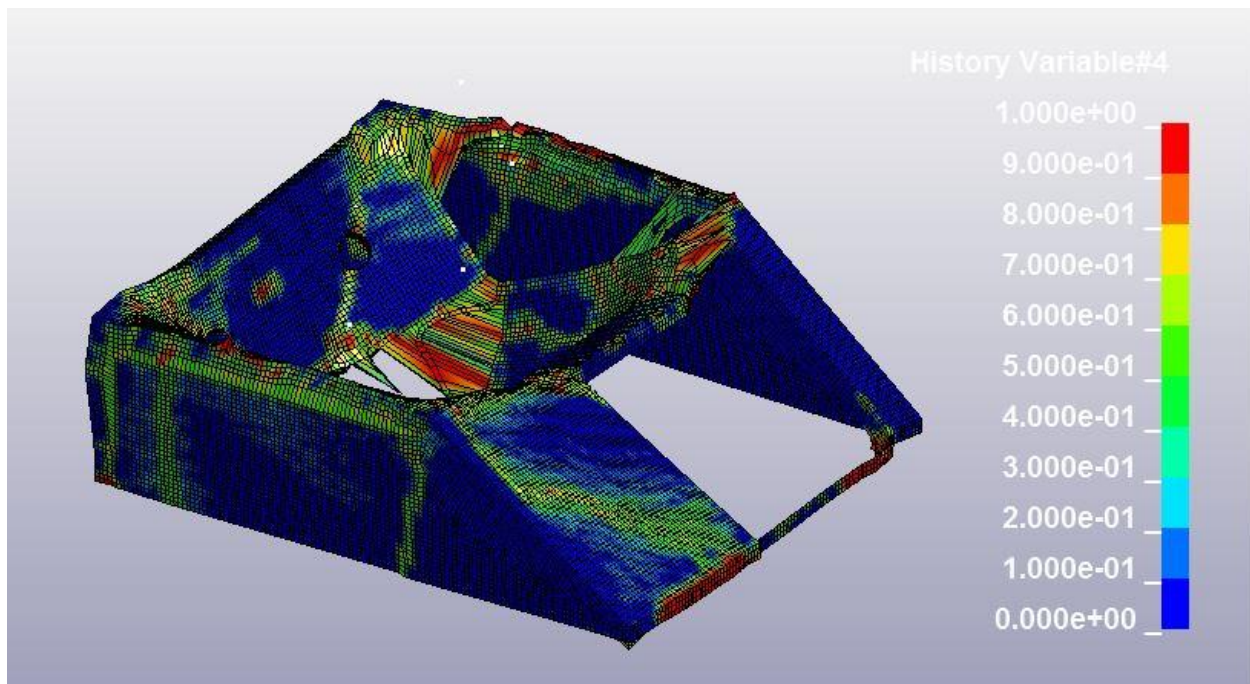
Figure 5.2.2: 14-Inch slope face shelter(14" Run 3) impact at 0.150s. Holes have formed in the shelter roof. The simulation has reached normal termination.

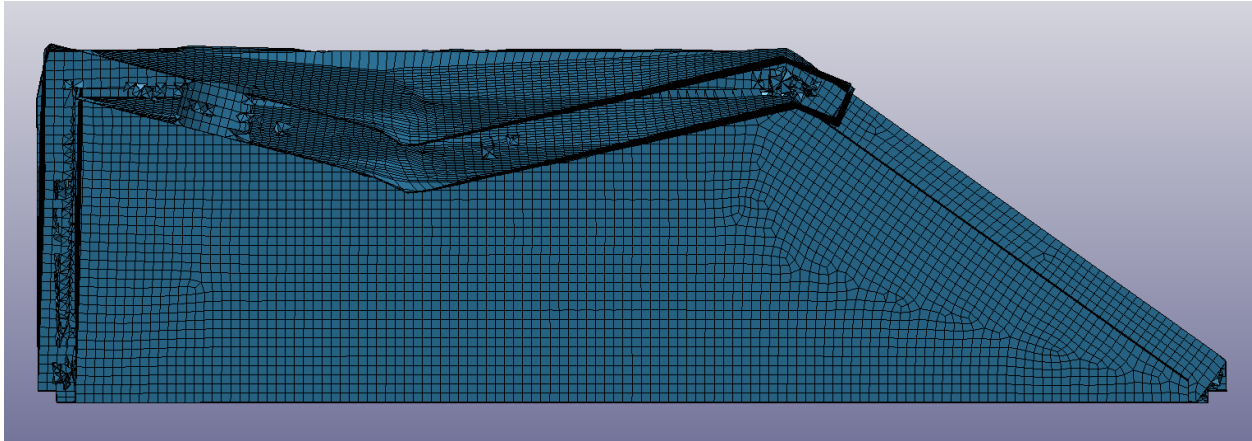
Figure 5.2.3: 14-Inch Rebar Model (14" Run 3) cross section, displaying maximum deflection in the concrete before holes formed in the structure. The capture was taken 0.063s into the simulation.

Figure 5.2.3 shows the cross-sectional view of the maximum displacement immediately before holes formed in the structure. This image shows large plastic deformation on the roof of the structure during impact and shearing of the elements on the edges. The maximum rigid body displacement was found to be 137 mm, while the elements at the center displace 172 mm. The rigid body deflection in the vertical direction is shown in **Figure 5.2.4**. The maximum acceleration was 78 m/s², shown in **Figure 5.2.5**.

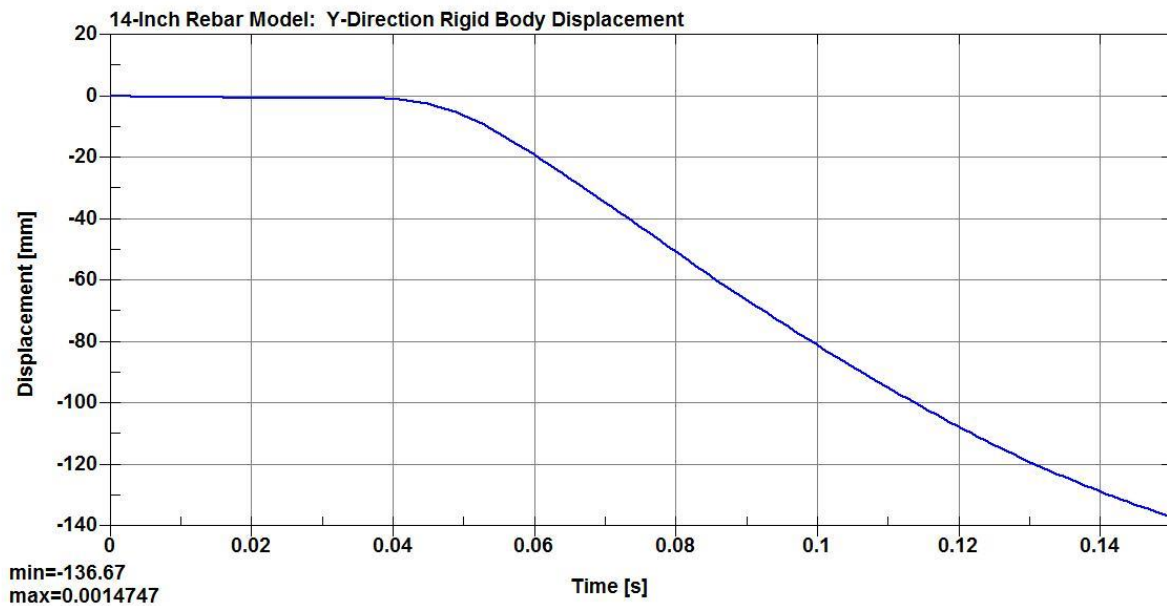
Figure 5.2.4: 14-Inch Rebar Model (14" Run 3): Rigid Body Vertical Displacement of the slope face shelter top with no filter applied.

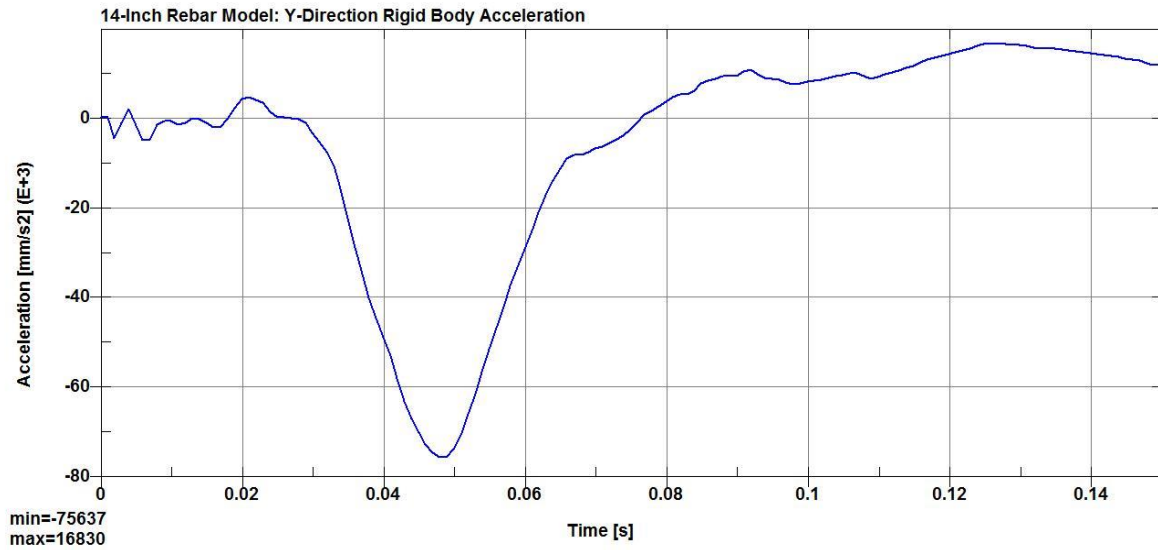
Figure 5.2.5: 14-Inch Rebar Model (14" Run 3): Rigid body acceleration of the slope face shelter top in the vertical direction. A 9-point averaging filter was applied to better isolate the acceleration signal from the noise.

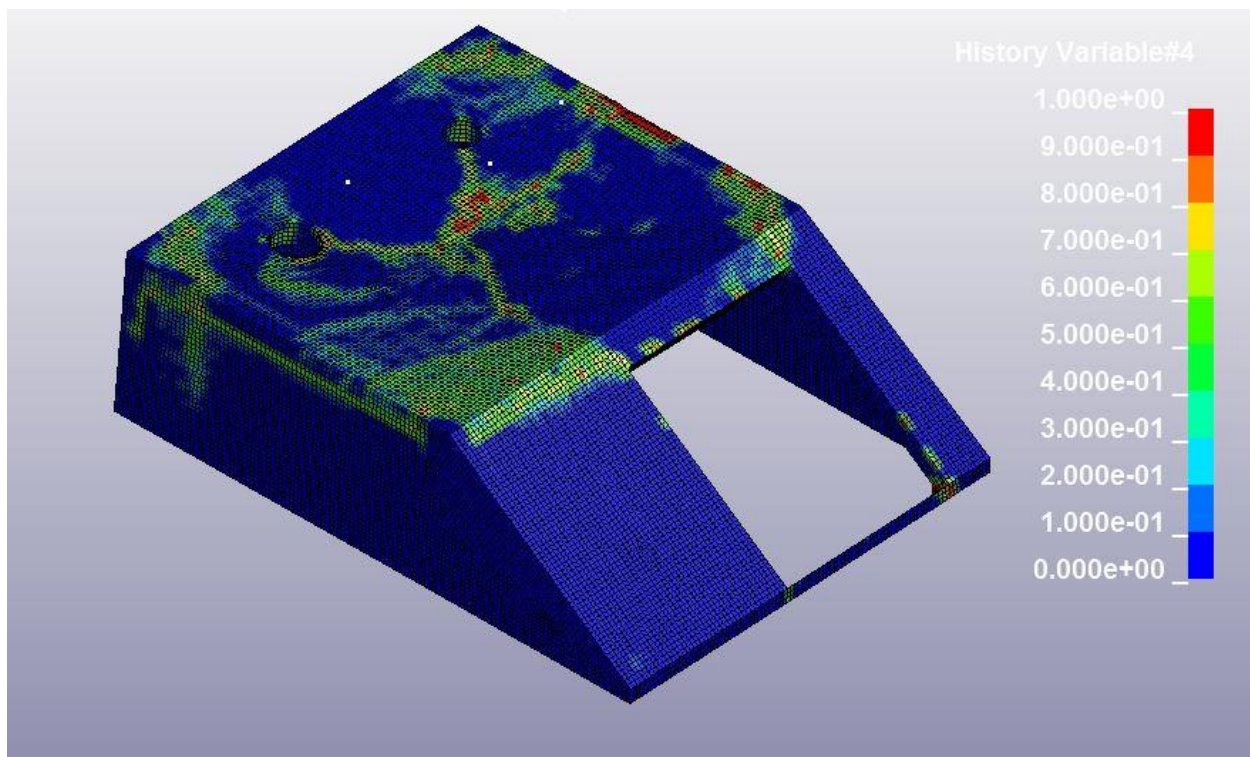
Figure 6.1.1: 12-Inch slope face shelter (12" Run 14) impact at 0.049s. The first cracks are appearing in the center of the roof.

From **Figures 6.1.1** and **6.1.2**, it can be seen that the slope face shelter begins failing as previously observed. Under these conditions, one of the side walls experienced large deflection in the lateral direction, causing the roof to detach from the wall. The roof continued to sink and deflect until it failed catastrophically. **Figure 6.1.3** shows the cross-sectional view of the maximum displacement immediately before holes formed in the structure. **Figure 6.1.4** shows the rigid body displacement for the top during the time of simulation. Averaging the entire rigid body displacement of the roof, the top of the shelter sinks 148 mm. However, selecting nodes at the center of the shelter roof, the displacement was seen to be 201 mm immediately before holes began forming. The maximum acceleration was 73.5 m/s^2 , as shown in **Figure 6.1.5**.

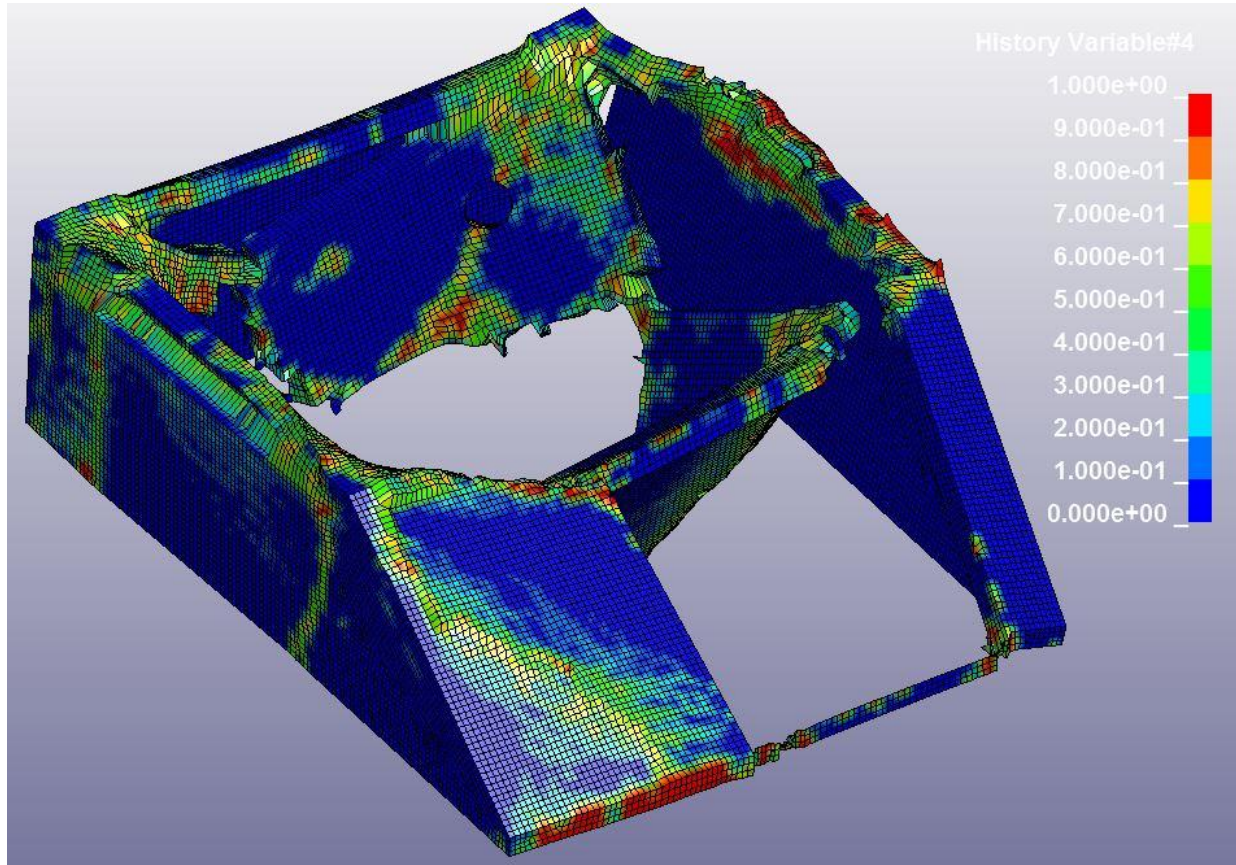
Figure 6.1.2: 12-Inch slope face shelter (12" Run 14) impact at 0.167s. Holes have formed in the shelter roof.

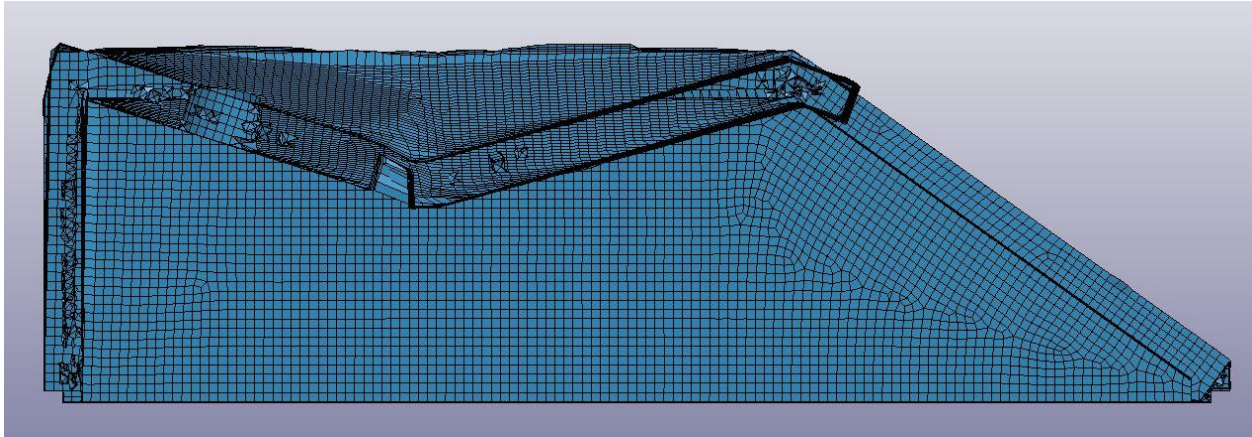
Figure 6.1.3: 12-Inch Rebar Model (12" Run 14) cross section, displaying maximum deflection in the concrete before holes formed in the structure. The capture was taken 0.063s into the simulation.

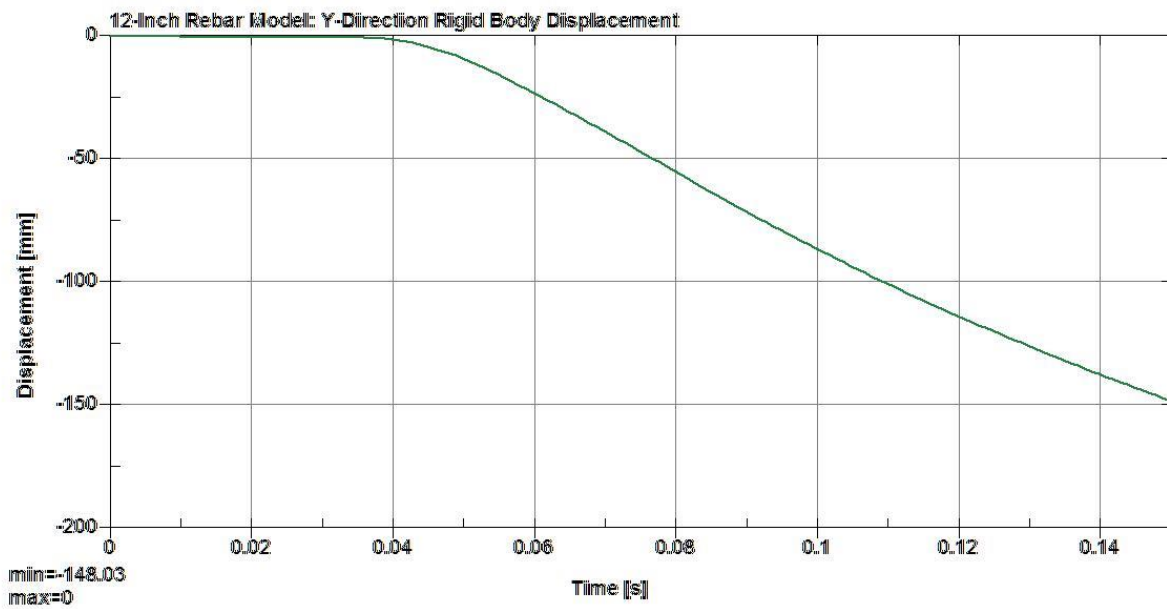
Figure 6.1.4: 12-Inch Rebar Model (12" Run 14): Rigid Body Vertical Displacement of the slope face shelter top with no filter applied.

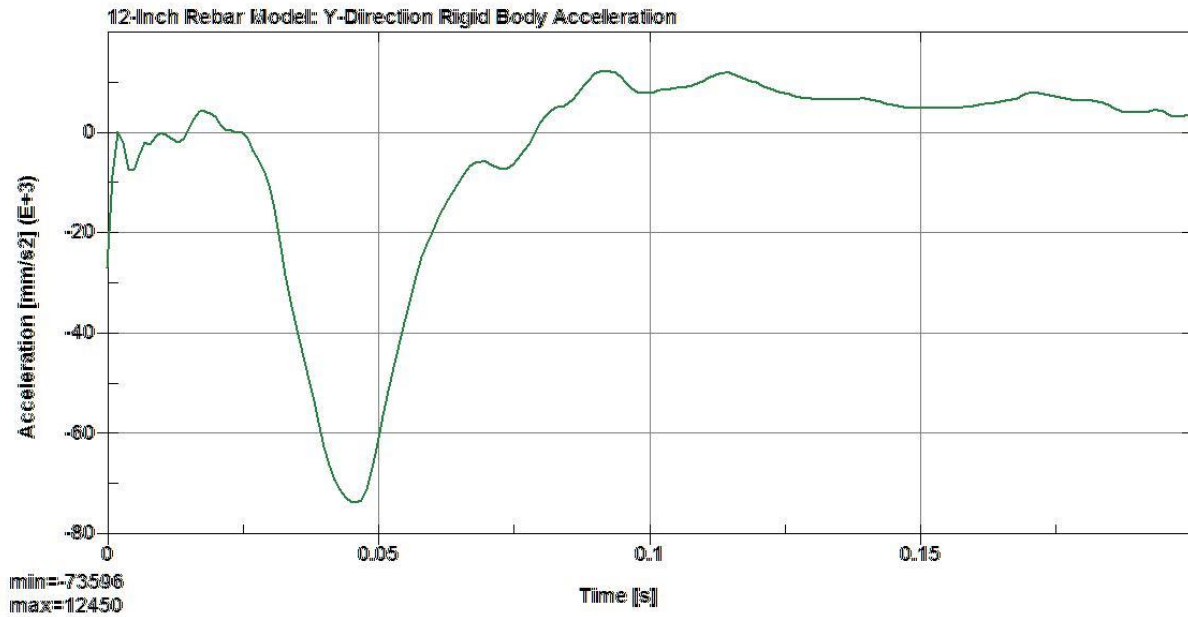
Figure 6.1.5: 12-Inch Rebar Model (12" Run 14): Rigid body acceleration of the slope face shelter top in the vertical direction. A 9-point averaging filter was applied to better isolate the acceleration signal from the noise.

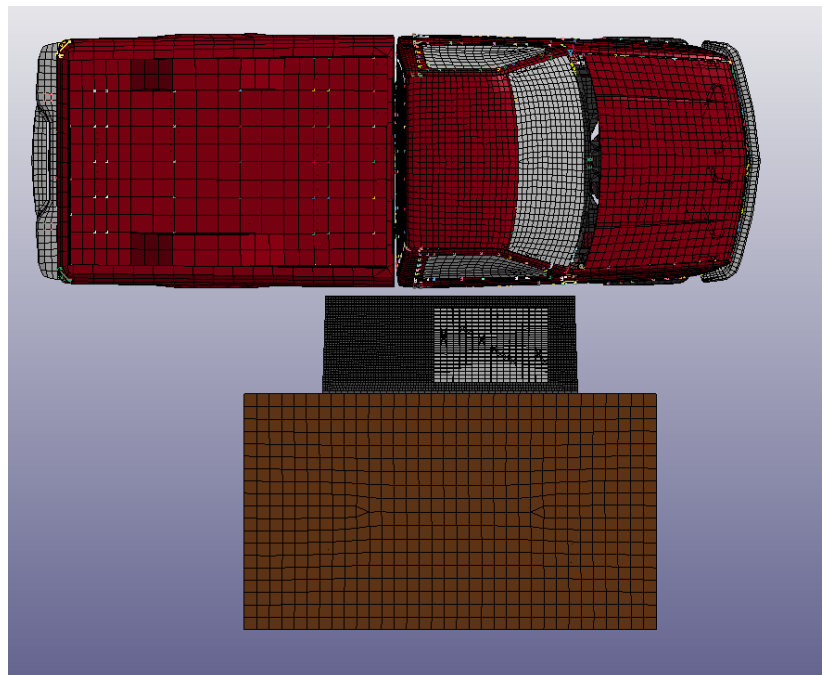
Figure 6.2: Experimental setup of lateral pickup truck drop using detailed Chevrolet C2500 model, as provided by the NCAC/CCSA [3].

For this simulation, the truck was repositioned horizontally, maintaining the same downward initial velocity of 35 mph, as seen in **Figure 6.2**. An Eroding Plastic Strain parameter of 1 and the Hourglass settings used in Section 6.1 were incorporated.

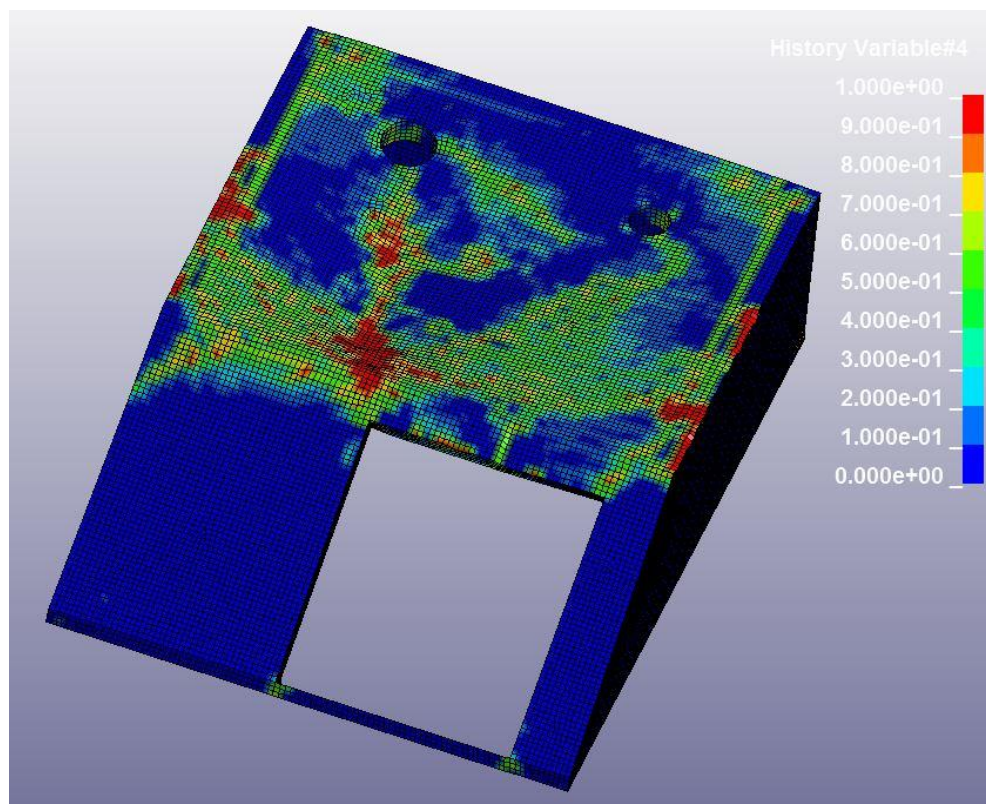
Figure 6.2.1: 12-Inch Lateral slope face shelter (12" Run 12) impact at 0.020s. Cracks begin forming on the edges of the shelter and damage is seen more evenly distributed across the roof.

Figures 6.2.1 and 6.2.2 show the progression of damage accumulated by the shelter roof during the lateral impact at key instants during the simulation. The full animation of the simulation is captured on the attached CD, under filenames **RUN12_Top_HV4.wmv** and **RUN12_Front_HV4.wmv**.

From these figures, it can be seen that the shelter begins to fail along the edges before caving in at its center and forming holes. As in all previous cases, the door lost contact with its supports and warped as a result of the impact.

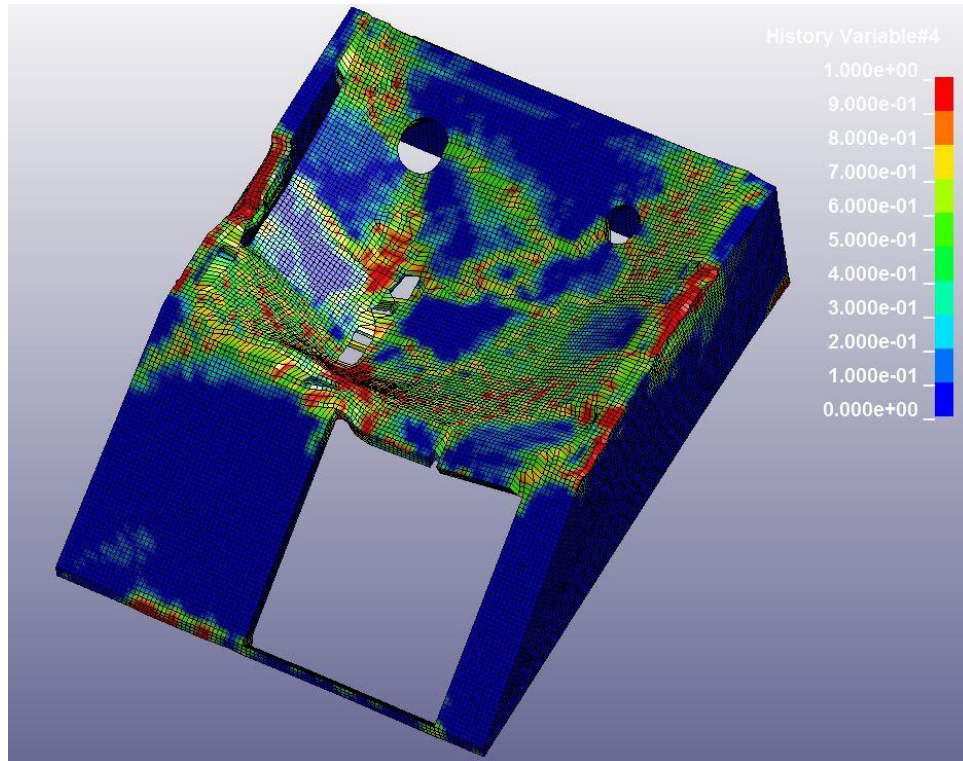
Figure 6.2.2: 12-Inch slope face shelter (12" Run 12) impact at 0.095s. The edges of the shelter have accumulated considerable damage and holes are forming at the center.

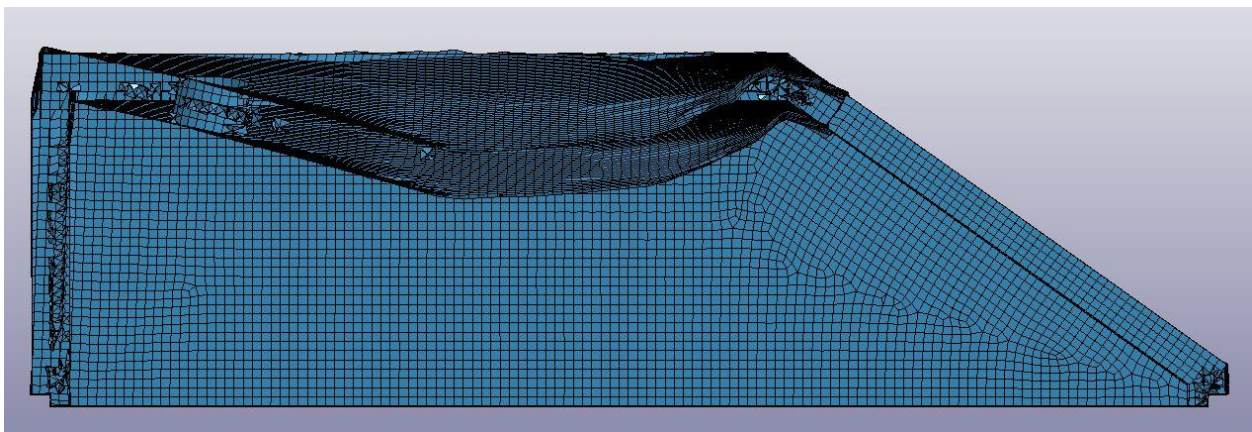
Figure 6.2.3: 12-Inch Rebar Model (12" Run 12) cross section, displaying maximum deflection in the concrete before holes formed in the structure. The capture was taken 0.43s into the simulation.

Figure 6.2.3 shows the cross-sectional view of the maximum displacement immediately before holes formed in the structure. **Figure 6.2.4** shows the rigid body displacement for the top part during the time of simulation. Averaging the entire rigid body displacement of the roof, the top of the shelter sinks 77 mm. However, selecting nodes at the center of the shelter roof, the displacement was seen to be 287 mm immediately before holes began forming. The maximum acceleration was 25 m/s^2 , shown in **Figure 6.2.5**.
