Finite Element Analysis of Slope Face Storm Shelter

Technical Report Submitted to
OZ Saferooms, Del City, OK.

Rochester Institute of Technology

October 2017

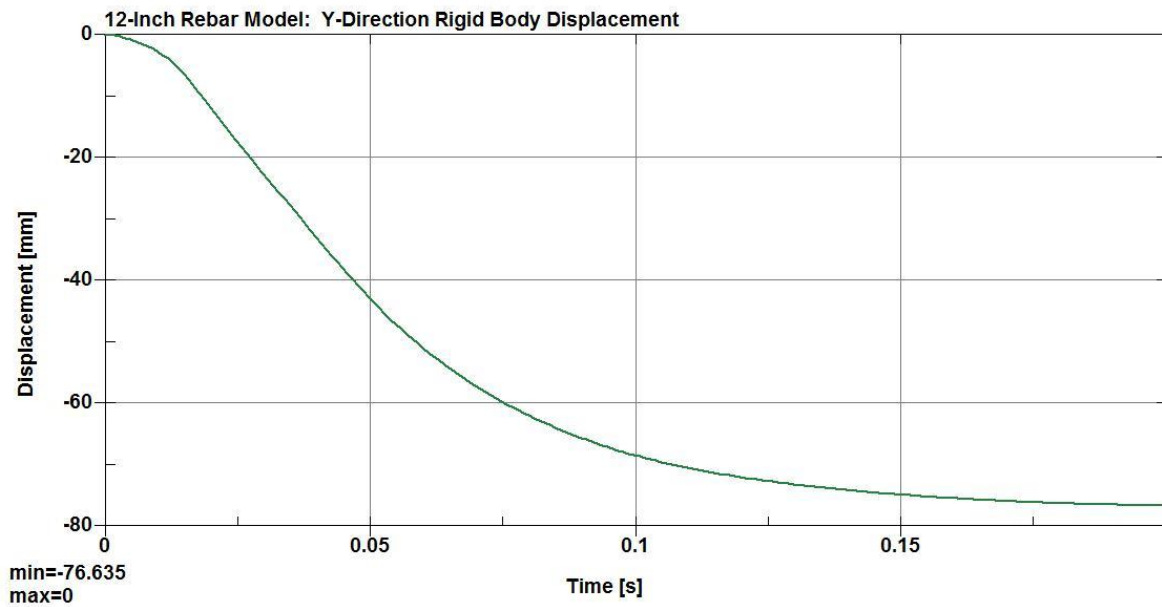
Figure 6.2.4: 12-Inch Rebar Model (12" Run 12): Rigid Body Vertical Displacement of the slope face shelter top with no filter applied.

Figure 6.2.3 shows the cross-sectional view of the maximum displacement immediately before holes formed in the structure. **Figure 6.2.4** shows the rigid body displacement for the top part during the time of simulation. Averaging the entire rigid body displacement of the roof, the top of the shelter sinks 77 mm. However, selecting nodes at the center of the shelter roof, the displacement was seen to be 287 mm immediately before holes began forming. The maximum acceleration was 25 m/s^2 , shown in **Figure 6.2.5**.

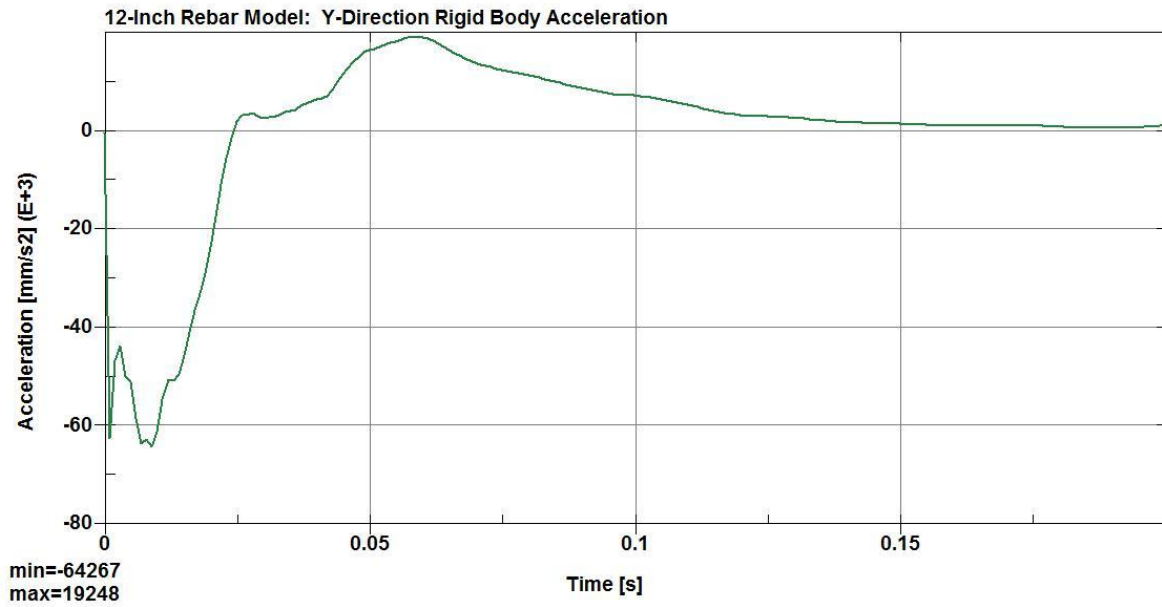
Figure 6.2.5: 12-Inch Rebar Model (12" Run 12): Rigid body acceleration of the slope face shelter top in the vertical direction. A 9-point averaging filter was applied to better isolate the acceleration signal from the noise.

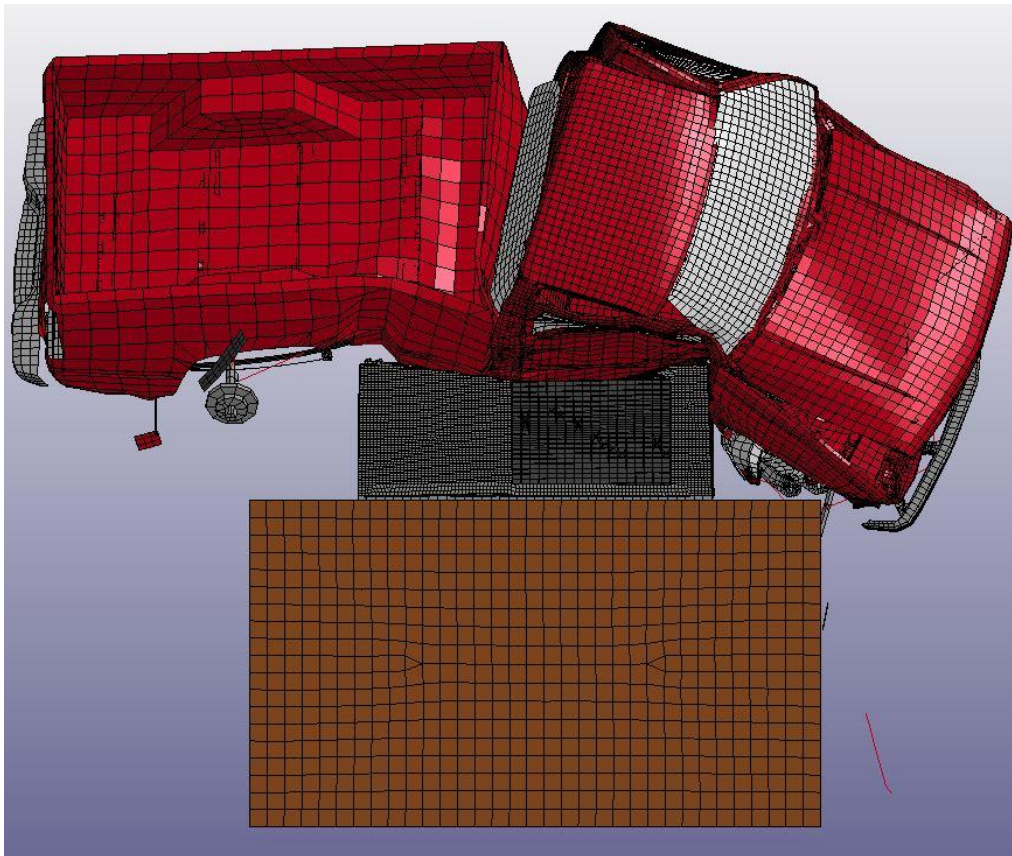
Figure 6.3: Post-simulation lateral collision of the pickup truck into the slope face shelter.

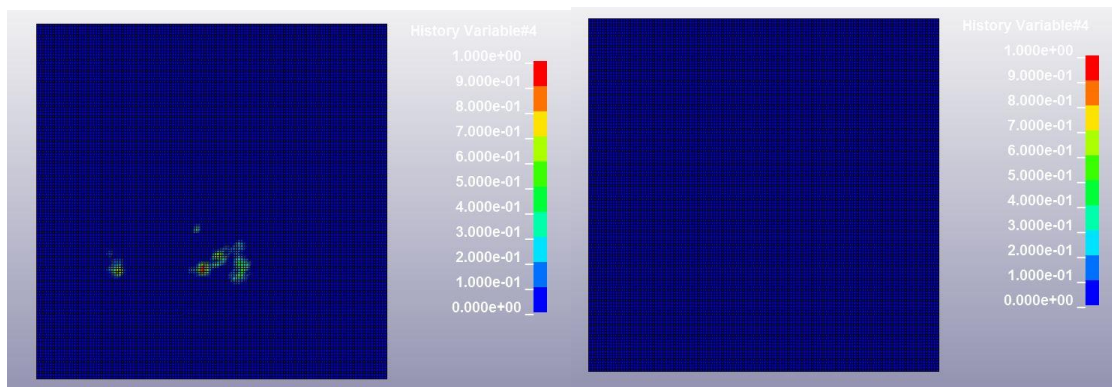
Figure 7.1.1: OZ Saferoom Model: Damage accumulation of roof elements. The left image displays the top surface of the roof. The right image displays the bottom surface. Notice that there is considerably less stress and warpage seen in the OZ saferoom than there was for either of the Hausner shelter designs.

For the 20° impact test, the OZ saferoom withstood the impact of the airborne vehicle without warping or failing under the same initial conditions and input parameters. **Figure 7.1.1**, displaying only the roof of the saferoom, presents the damages experienced during simulation. Only minor damage is seen on the top surface of the roof and no damage was incurred on the bottom surface. This indicates that there is no penetration of the truck to the saferoom and that the saferoom withstands the impact completely. The full animation of the simulation is captured on the attached CD, under filenames **OZ20deg_Top_HV4** and **OZ20deg_Front_HV4**.

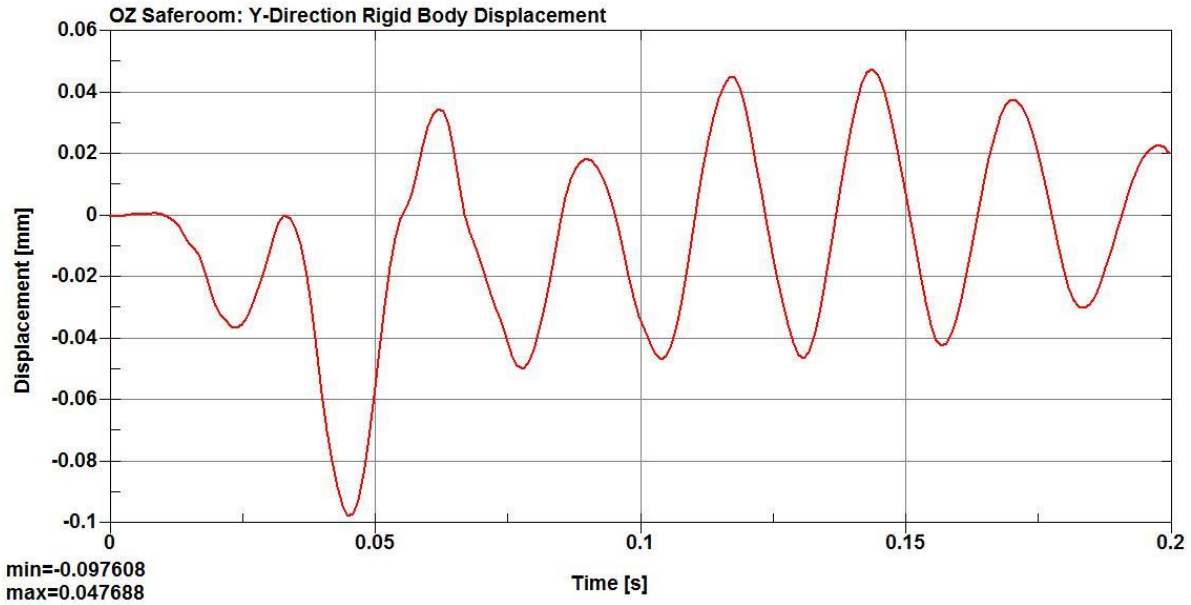
Figure 7.1.2: OZ Saferoom Model: Rigid body vertical displacement of the roof center with no filter applied. Notice that the displacement is oscillatory in nature, absorbing the shock and suffering minimal damage consequently.

According to **Figures 7.1.2** and **7.1.3**, a maximum vertical rigid body displacement of 0.0976 mm and a maximum vertical rigid body acceleration of 1.17 m/s² were seen in the OZ saferoom analysis. Therefore, the Hausner shelter vertically deforms approximately 1500 times more and accelerates approximately 60 times more than the OZ saferoom. From **Figure 7.1.2**, it can also be seen that the roof of the OZ saferoom oscillates to absorb the impact energy, whereas the roof of the slope face shelter sinks as seen previously in **Figure 7.1.5**.

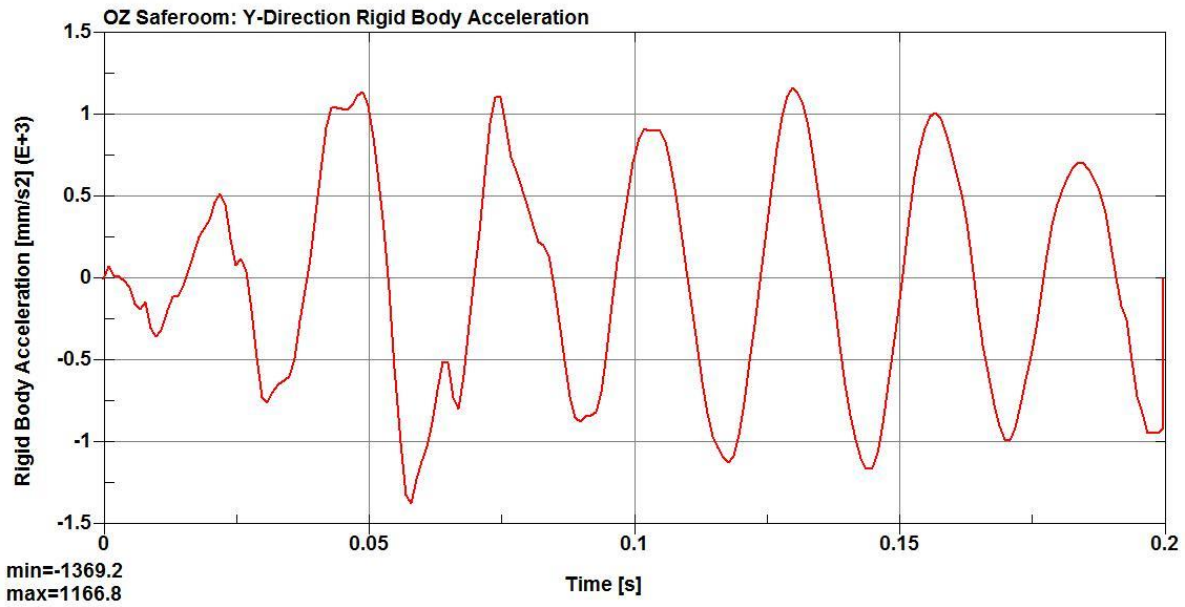
Figure 7.1.3: OZ Saferoom Model: Rigid body acceleration of the shelter top in the vertical direction. A 9-point averaging filter was applied to better isolate the acceleration signal from the noise. The acceleration is oscillatory in nature, absorbing the shock and suffering minimal damage consequently.

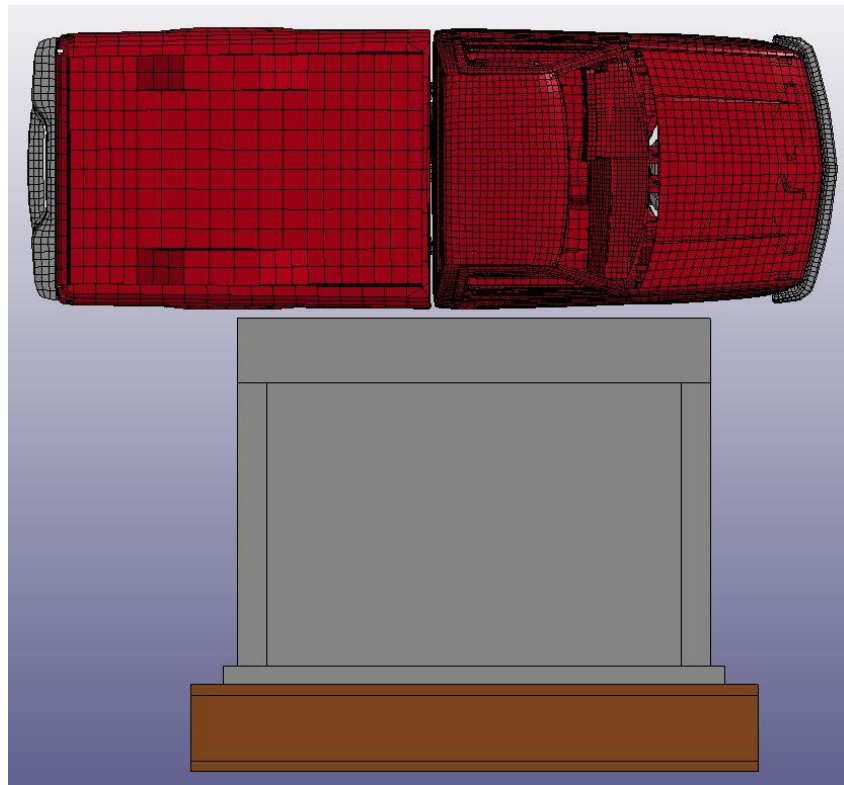
Figure 7.2.1: Experimental setup of lateral pickup truck drop on OZ saferoom.

Similarly, in the lateral impact test, the OZ saferoom withstood the impact of the airborne vehicle. Once again, no warpage or failure was seen in the saferoom roof under the same initial conditions and input parameters. **Figure 7.2.1** displays the initial setup for this simulation. **Figure 7.2.2** displays a snapshot of the simulation at the greatest point of impact between the truck and the saferoom.

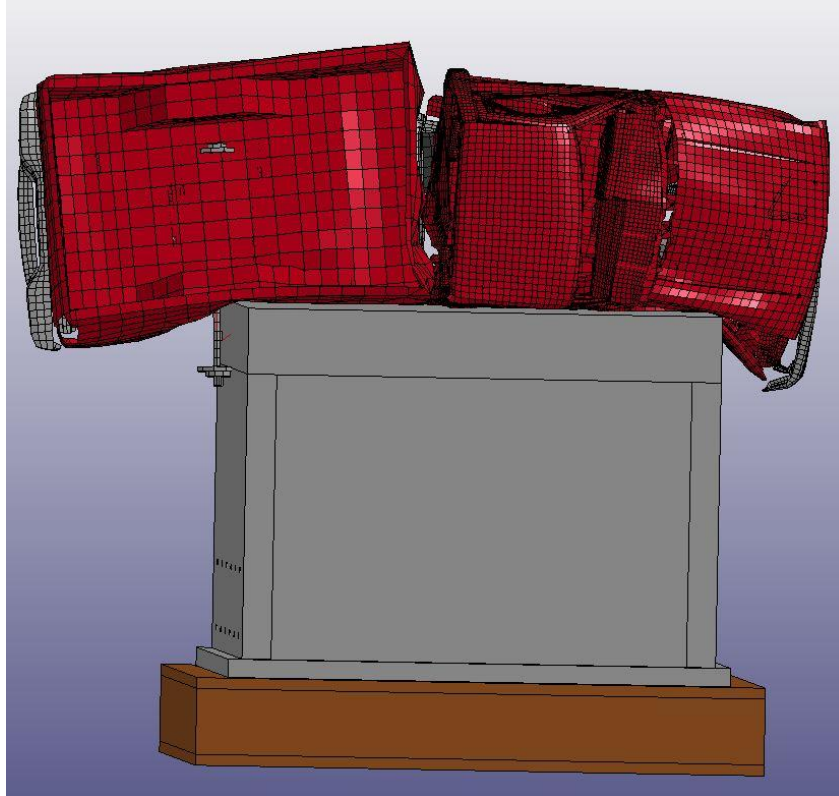
Figure 7.2.2: Post-simulation lateral collision of the pickup truck into the OZ saferoom.

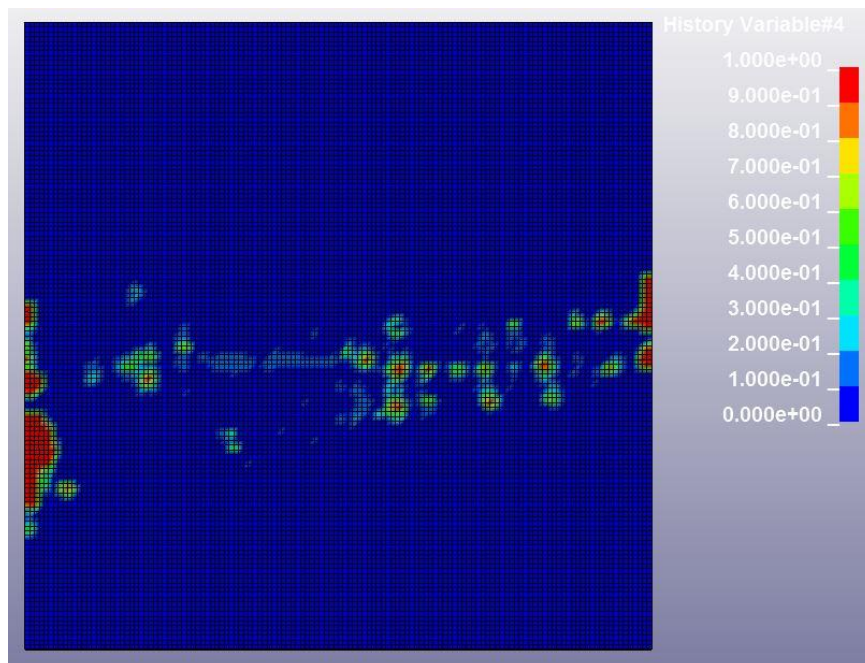
Figure 7.2.3: OZ Saferoom Model: Damage accumulation of roof elements post-simulation.

Figure 7.2.3 analyzes the damage accumulation on the top of the saferoom roof. An image displaying the bottom of the saferoom roof has been omitted, as once again, there was no visible damage. From **Figure 7.2.3**, it can be seen that some superficial damage exists primarily on the roof edges, but it does not penetrate through the thickness of the roof. As before, no penetration of the truck was observed during simulation. The full animation of the simulation is captured on the attached CD, under filenames **OZLat_Top_HV4.wmv** and **OZLat_Front_HV4.wmv**.

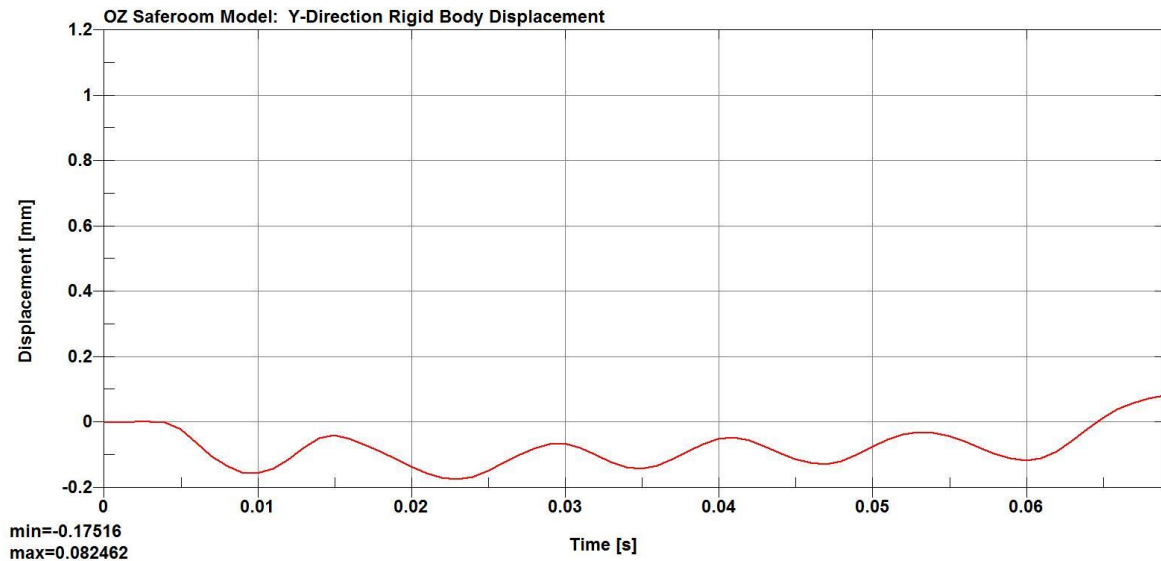
Figure 7.2.4: OZ Saferoom Model: Resultant nodal displacement of the roof center with no filter applied. Notice that the displacement is oscillatory in nature, absorbing the shock and suffering minimal damage consequently.

Figures 7.2.4 and 7.2.5 present the Rigid Body Displacement and Acceleration of the roof of the OZ saferoom up to the point of maximum contact between the truck and the roof. A maximum vertical rigid body displacement of 0.175 mm and a maximum vertical rigid body acceleration of 2.89 m/s^2 were seen in the OZ saferoom lateral analysis. Therefore, the Hausner shelter vertically deforms approximately 800 times more and accelerates approximately 25 times more than the OZ saferoom. From **Figure 7.2.4**, it can also be seen that the roof of the OZ saferoom again oscillates to absorb the impact energy.

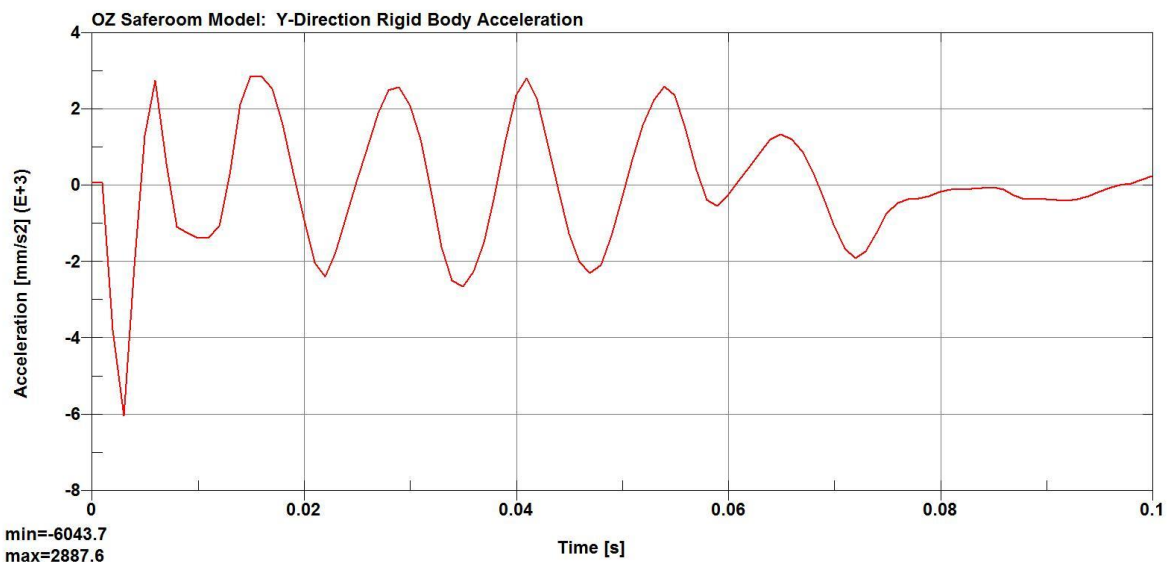
Figure 7.2.5: OZ Saferoom Model: Rigid body resultant acceleration of the shelter top. A 9-point averaging filter was applied to better isolate the acceleration signal from the noise. The acceleration is oscillatory in nature, absorbing the shock and suffering minimal damage consequently.
